# 29 PRESERVATION BRIEFS

## The Repair, Replacement, and Maintenance of Historic Slate Roofs

Jeffrey S. Levine

U.S. Department of the Interior  
National Park Service  
Cultural Resources  
Preservation Assistance

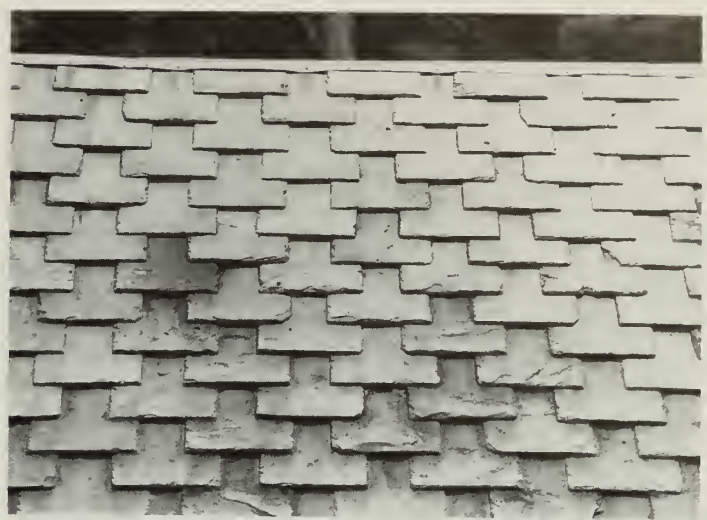
Figure 4. Widely spaced open slating was often used on utilitarian structures where ventilation was desirable. It provided an interesting texture and visual pattern to often plain structures.

Historically, three types of slate roofing—standard, textural, and graduated—were available according to the architectural effect desired. Standard grade slate roofs were most common. These are characterized by their uniform appearance, being composed of slates approximately  $3/16"$  (0.5cm) thick, of consistent length and width, and having a smooth cleavage surface. Thirty different standard sizes were available, ranging from  $10" \times 6"$  to  $24" \times 14"$  (15cm  $\times$  61cm  $\times$  35cm). The slates were laid to break joints and typically had square ends and uniform color and exposure. Patterned and polychromatic roofs were created by laying standard slates of different colors and shapes on the roof in such a way as to create sunbursts, flowers, sawtooth and geometric designs, and even initials and dates (Figure 3). On utilitarian structures, such as barns and sheds, large gaps were sometimes left between each slate within a given course to reduce material and installation costs and provide added ventilation for the interior (Figure 4).

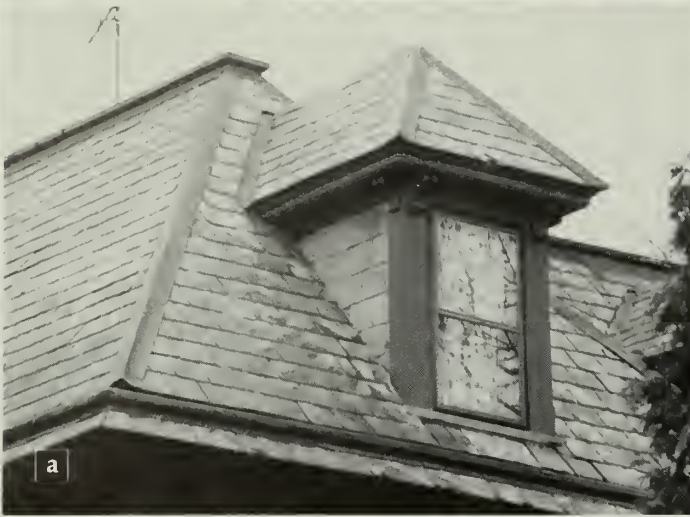
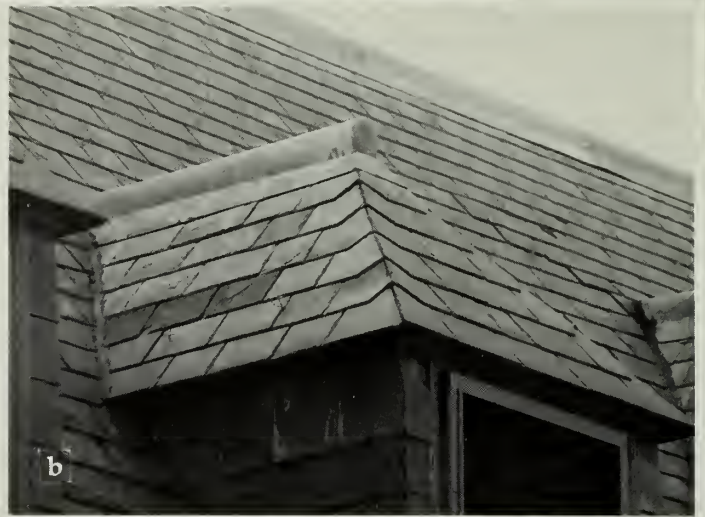
Figure 6. Hips are formed at the external angle of two roofing slopes. In (a), the hips at both the roof and the dormer are covered with metal. Note also the open valley and the built-in gutter. In (b), the dormer hip slates have been laid in a fantail pattern to help shed water. Note also the metal ridge cap.

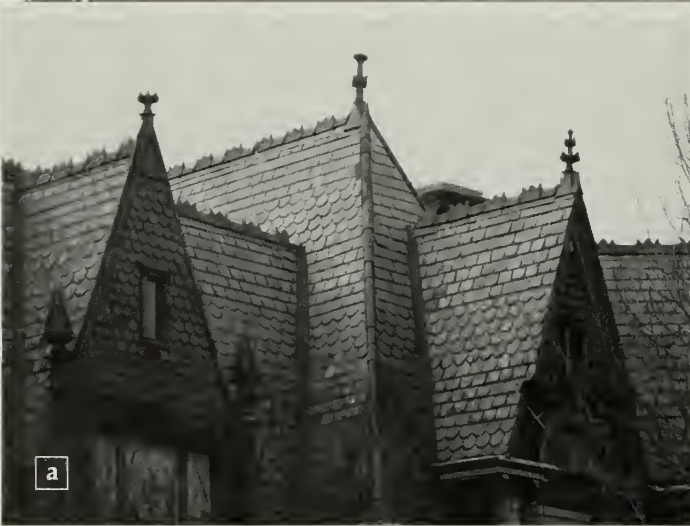
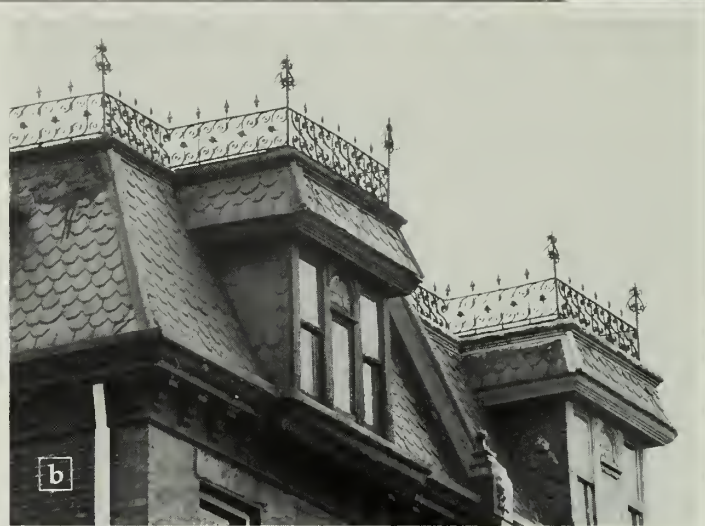
Figure 7. Ridge caps and cresting can be elaborate. Ridges are formed at the long horizontal juncture of two roofing slopes and capping protects this joint from moisture. In (a), a terra cotta capping with a decorative profile complements the finial over the various roof peaks. In (b), the mansard roof has a decorative iron cresting at the break between the lower and the upper roof slopes.

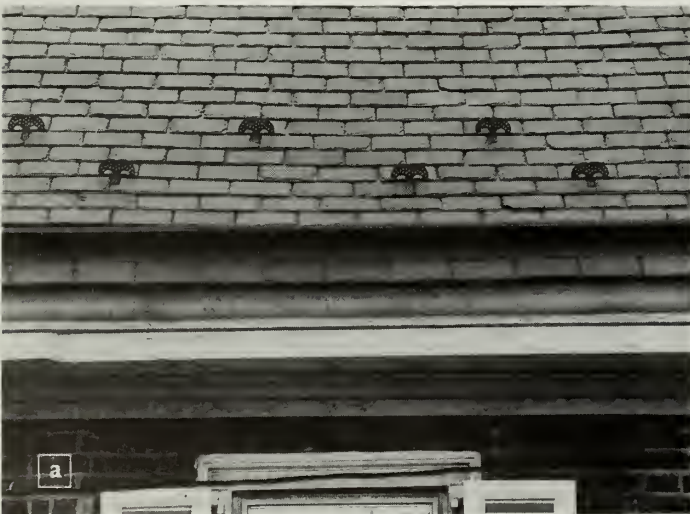
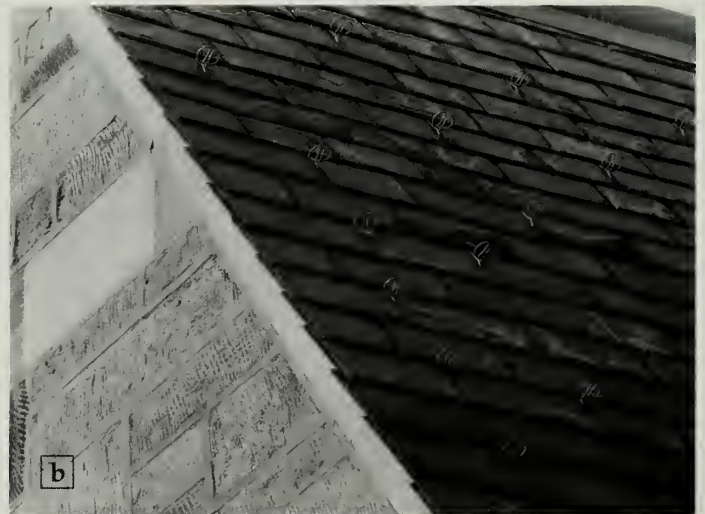
Figure 8. Eave details include snow guards, snow boards, gutter treatments. Snow guards are generally used in areas where ice and snow accumulate to avoid dangerous slides from the roof. In (a) the snow guards are set in two staggered rows above a pole gutter. In (b), the copper wire snow guards are set more frequently up a very steep gable.

Detailing at the hips, ridges and valleys provided added opportunity to ornament a slate roof. Hips and ridges can be fashioned out of slate according to various traditional schemes whereby the slates are cut and overlapped to produce a watertight joint of the desired artistic effect. Traditional slate ridge details are the saddle ridge, strip saddle ridge, and comb ridge, and for hips, the saddle hip, mitered hip, Boston hip, and fantail hip (Figure 6). A more linear effect was achieved by covering the ridges and hips with flashing called "cresting" or "ridge roll" formed out of sheet metal, terra cotta, or even slate (Figure 7). Snow guards, snow boards, and various types of gutter and rake treatments also contributed to the character of historic slate roofs (Figure 8).

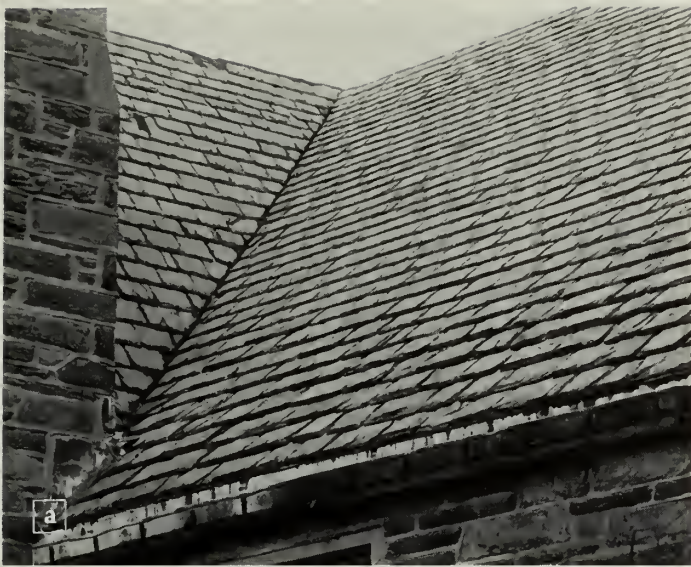
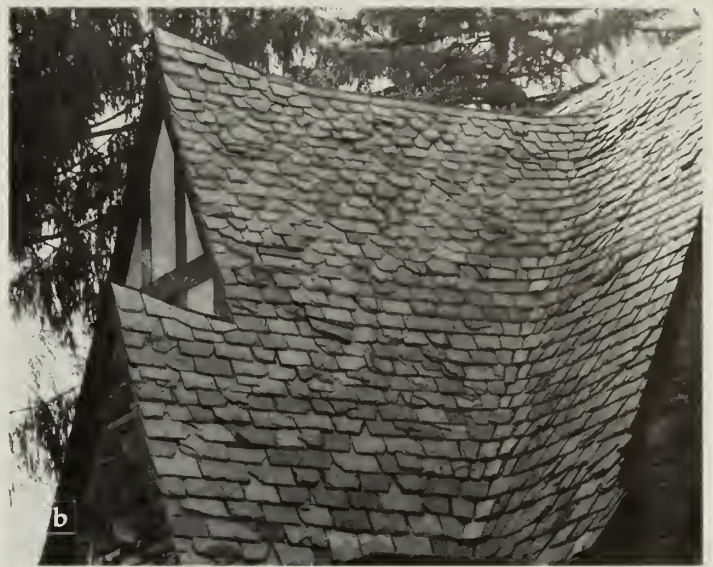
Figure 9. Valleys are formed at the internal angle of two roofing slopes. Flashing is often placed under the slate to increase moisture protect at this vulnerable joint. Show in (a) is a closed valley where the slates are held tight to the valley line. (b) illustrates of a round valley where the transition between the two slopes is a continuous curve. It requires careful workmanship and an experienced roofer.

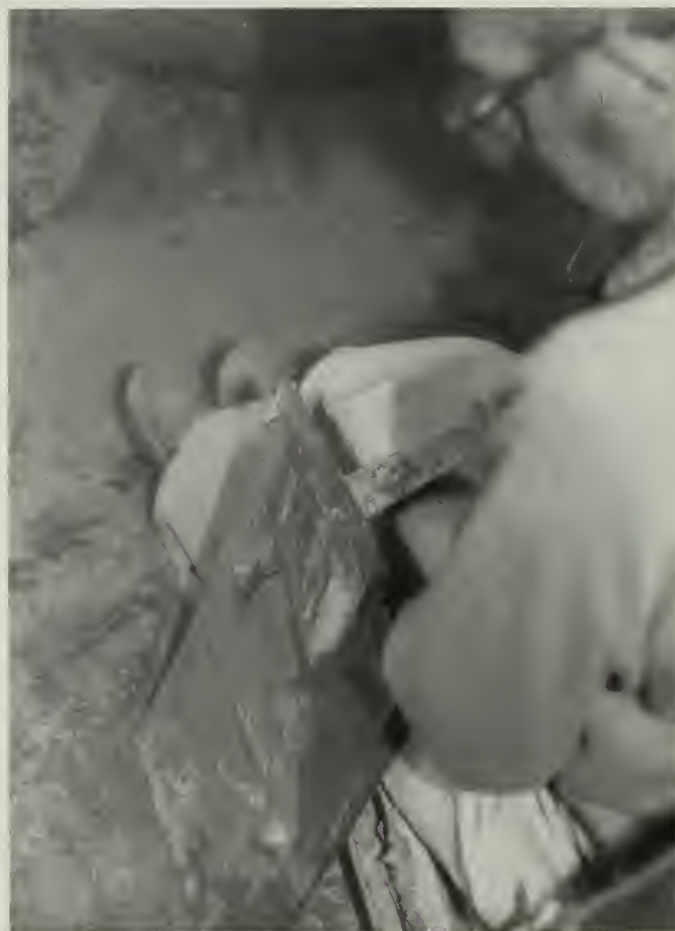
Figure 12. In the splitting area, the slightly oversized blocks are split along their cleavage planes. The splitter's tools consist of a wooden mallet and splitting chisels. The process of halving the split portions is repeated until a tile or shingle of appropriate thinness is obtained.

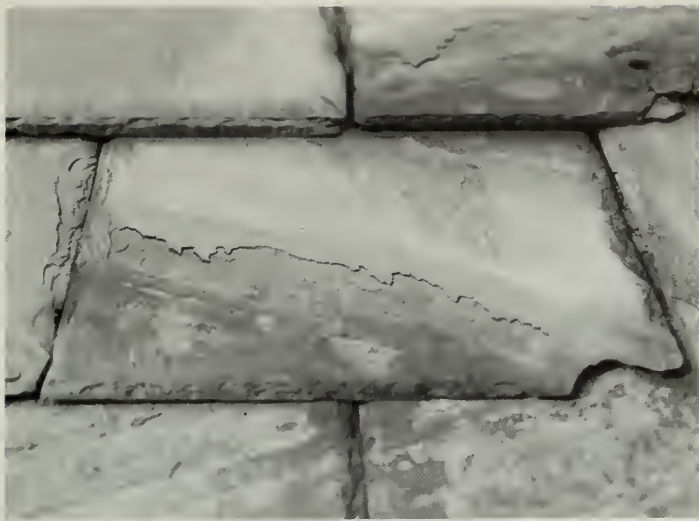
Figure 13. Paper thin lamination can be seen flaking off of this weathered, 120 year piece of Pennsylvania Hard-Vein slate.

The natural weathering of roofing slate manifests itself as a slow process of chipping and scaling along the cleavage planes (Figure 13). Paper thin laminations flake off the surface of the slate and the slate becomes soft and spongy as the inner layers begin to come apart, or delaminate. The nature of the sound given off by a slate when tapped with one's knuckles or slating hammer is a fair indication of its condition. High-grade slate, when poised upon the fingertips and struck, will emit a clear, solid sound. Severely weathered slates are much less sonorous, and give off a dull thud when tapped.

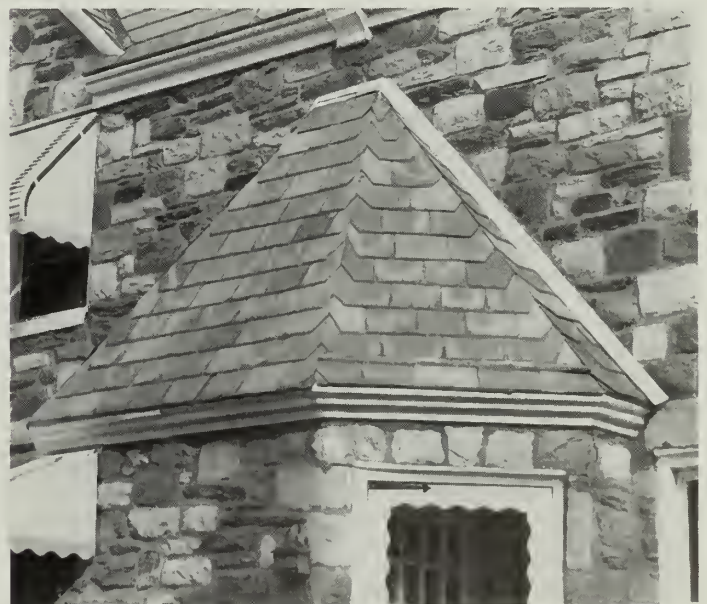
Figure 14. The white blotches on these Pennsylvania Soft-Vein slates indicate areas where gypsum is leaching out onto the surface of the slates.

The weathering of slate is chiefly due to mineral impurities (primarily calcite and iron sulfides) in the slate which, in concert with alternating wet/dry and hot/cold cycles, react to form gypsum (Figure 14). Because gypsum

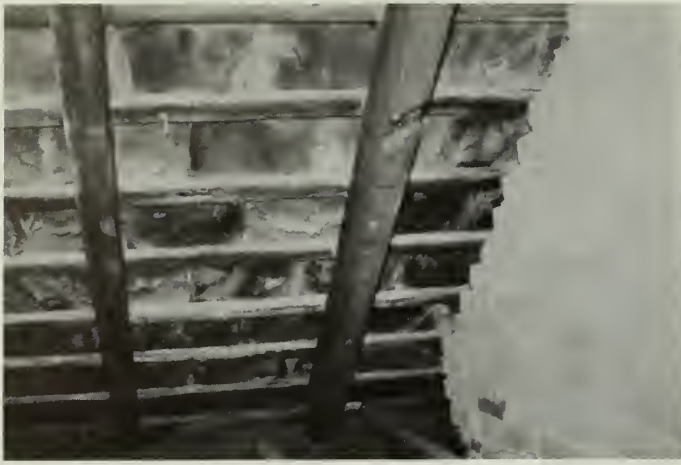
Figure 15. View of the underside of slates laid on open sheathing shows that delamination and flaking is just as bad or worse on the underside of slates as on the exposed surface. This is why most slates cannot be flipped over for reuse.

molecules take up about twice as much volume as calcite molecules, internal stresses result from the reaction, causing the slate to delaminate. This type of deterioration is as prominent on the underside of the roof as on the exposed surface due to the leaching and subsequent concentration of gypsum in this area (Figure 15). Consequently, deteriorated roofing slates typically cannot be flipped over and re-used.

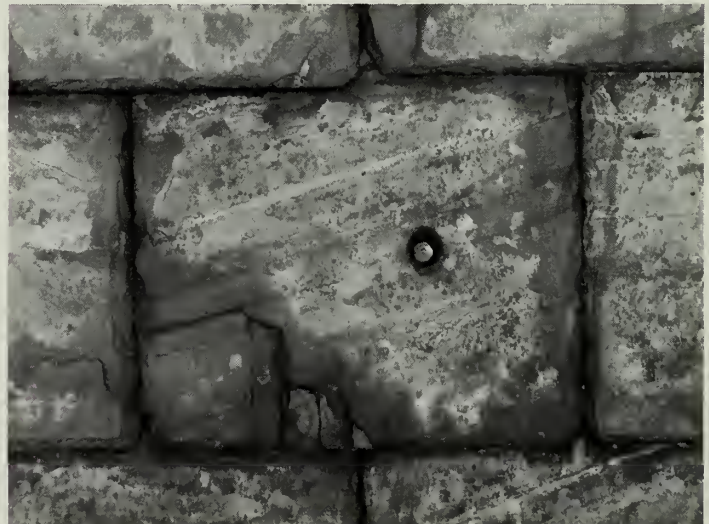
Figure 16. Detail view of a slate which has been punctured by the head of a nail used to secure the slate in the course below. Likely, the nail was not hammered in far enough when originally installed.

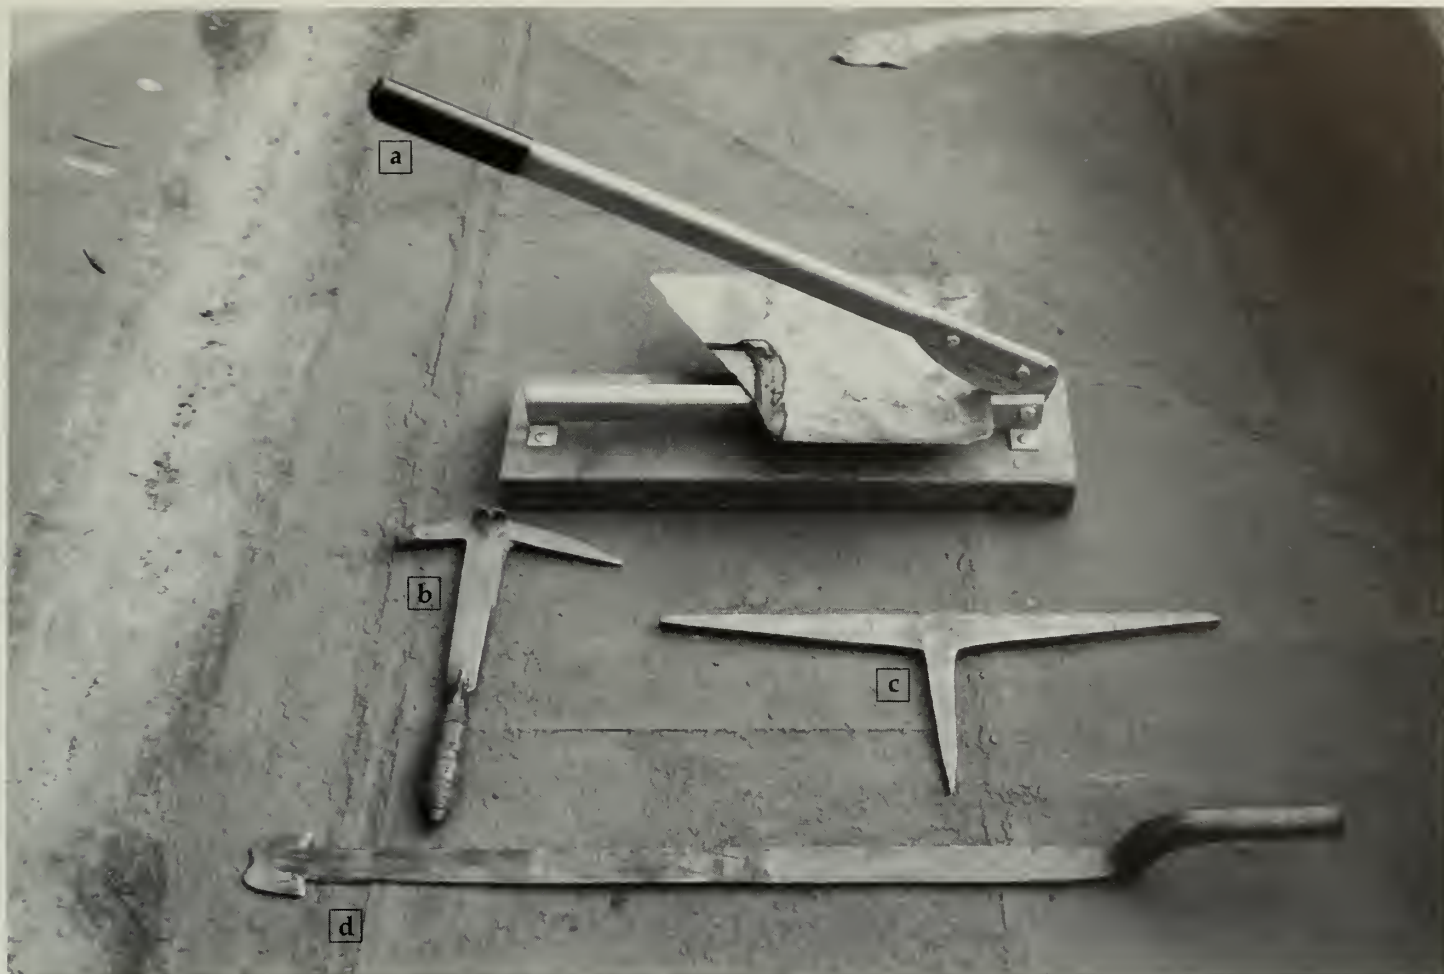
Figure 17. Slater's Tools. The cutter (a) is used to trim slate edges; the slate hammer (b) is used for hammering nails, trimming, cutting and punching holes in slates, and pulling roofing nails; the steak (c) is a T-shaped piece of iron upon which the slater places the edge of a slate to be trimmed; and the ripper (d) is slid under the slates to pull out the nails.

The ability to lay slate properly so as to produce a water-tight and aesthetically pleasing roof requires training, much practice, and the right tools (Figure 17). The

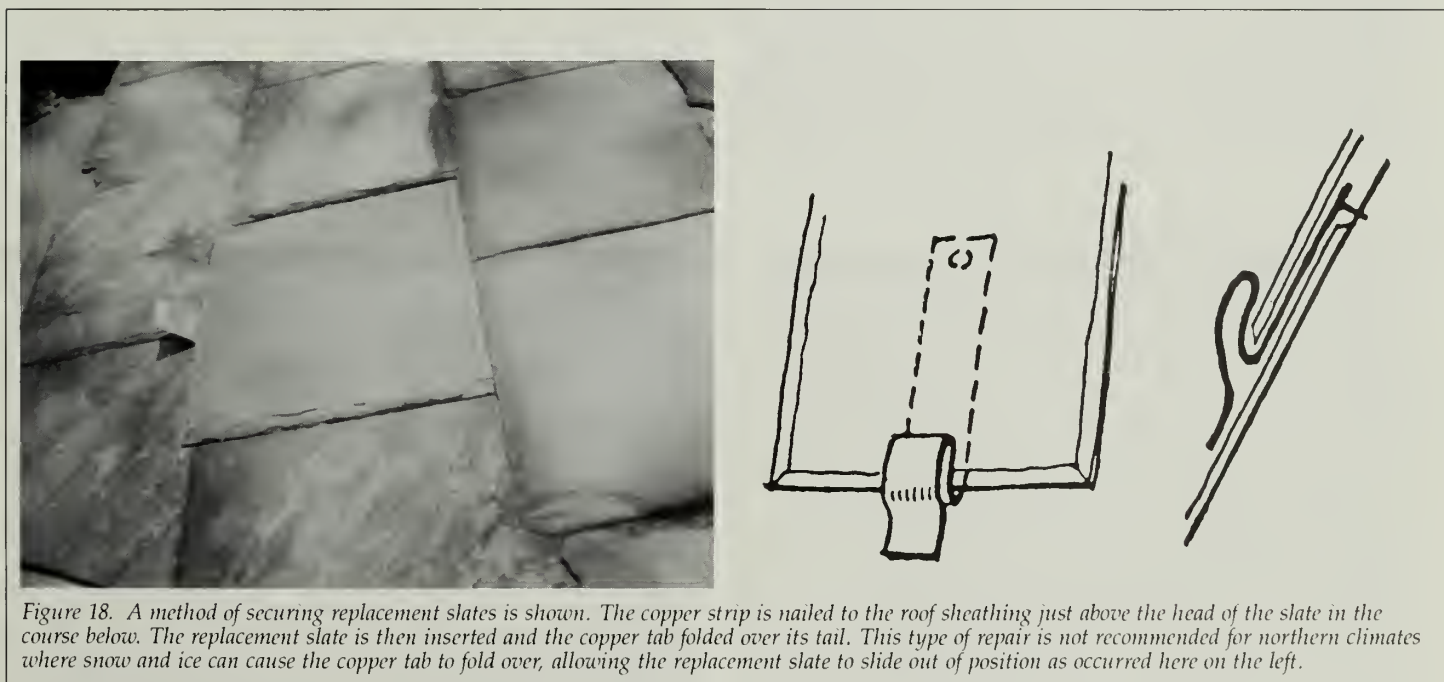
Figure 18. A method of securing replacement slates is shown. The copper strip is nailed to the roof sheathing just above the head of the slate in the course below. The replacement slate is then inserted and the copper tab folded over its tail. This type of repair is not recommended for northern climates where snow and ice can cause the copper tab to fold over, allowing the replacement slate to slide out of position as occurred here on the left.

Broken, cracked, and missing slates should be repaired promptly by an experienced slater in order to prevent water damage to interior finishes, accelerated deterioration of the roof and roof sheathing, and possible structural degradation to framing members (Figures 18 and 19).

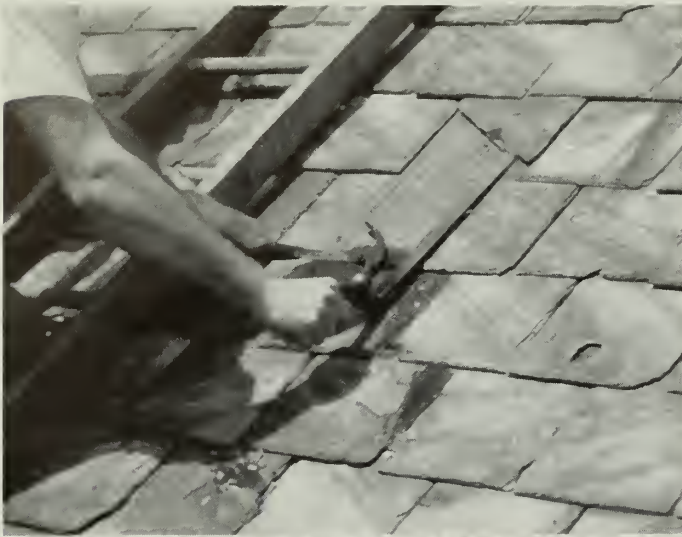
(a) A ripper is used to remove the nails from the deteriorated slate.

Figure 19. Above is a repair sequence for replacing a damaged slate.

The damaged slate is first removed by cutting or pulling out its nails with a ripper. If steel cut nails, rather than copper nails, were used in laying the roof, adjacent slates may be inadvertently damaged or displaced in the ripping process, and these, too, will have to be repaired. If the slate does not slide out by itself, the pointed end of the slate hammer can be punched into the slate and the slate dragged out. A new slate, or salvaged slate, which should match the size, shape, texture, and weathered color of the old slate, is then slid into place and held in position by one nail inserted through the vertical joint between the slates in the course above and approximately one inch below the tail of the slate two courses above. To prevent water penetration through the newly created nail hole, a piece of copper with a friction fit, measuring roughly 3" (7.5 cm) in width and 8" (20 cm) in length, is slid lengthwise under the joint between the two slates located directly above the new slate and over the nail. Alternate methods for securing the replacement slate include the use of metal hooks, clips, and straps that are bent over the tail end of the slate. The application of roofing mastic or sealants to damaged slates should *not* be considered a viable repair alternative because these materials, though effective at first, will eventually harden and crack, thereby allowing water to enter (Figure 20). Mastic also makes future repairs more difficult to execute, is unsightly, and, when applied to metal flashings, accelerates their corrosion.

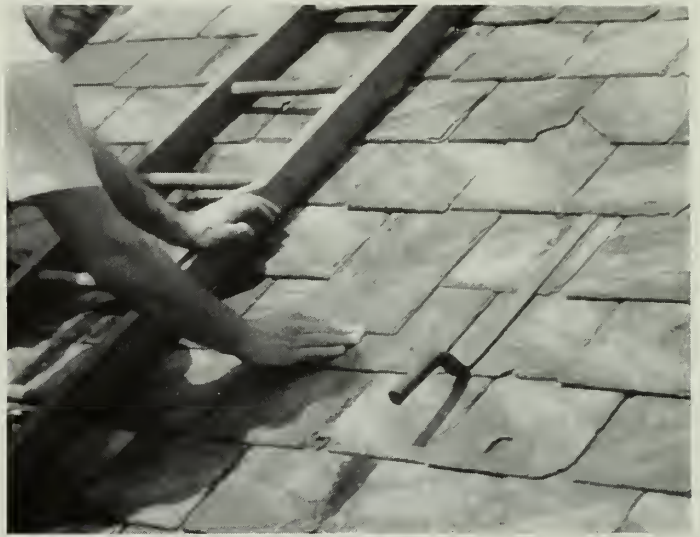
(b) A replacement slate is slid into place.

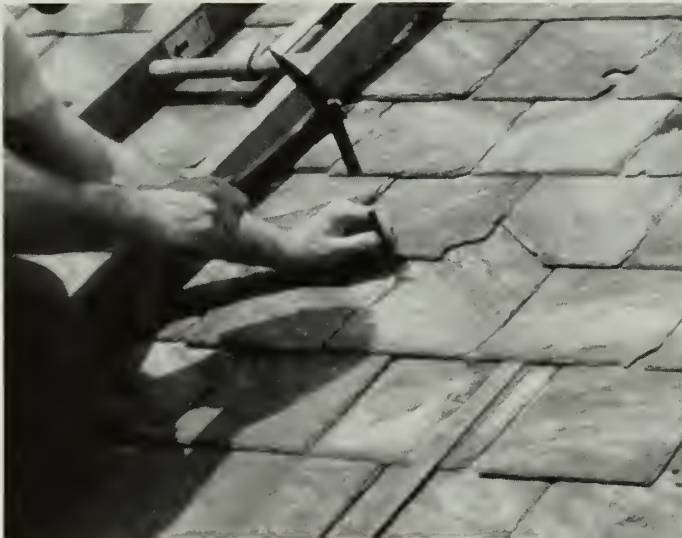
(c) A new slate is secured in place with a copper nail.

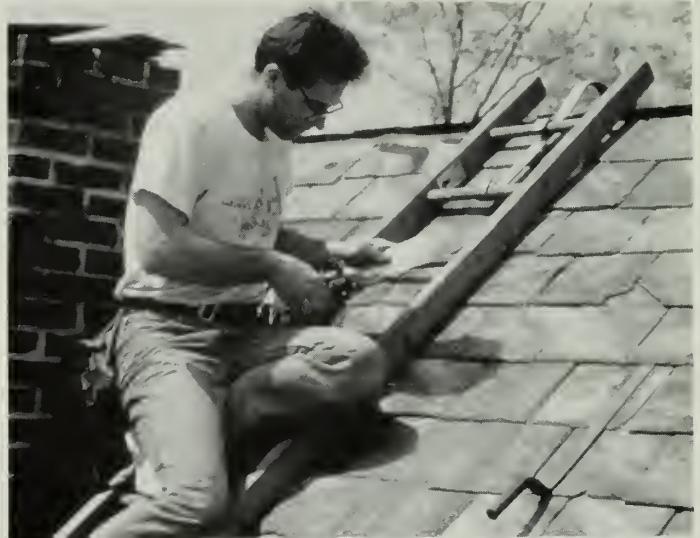
(d) A copper bib is formed to protect the newly created nail hole.

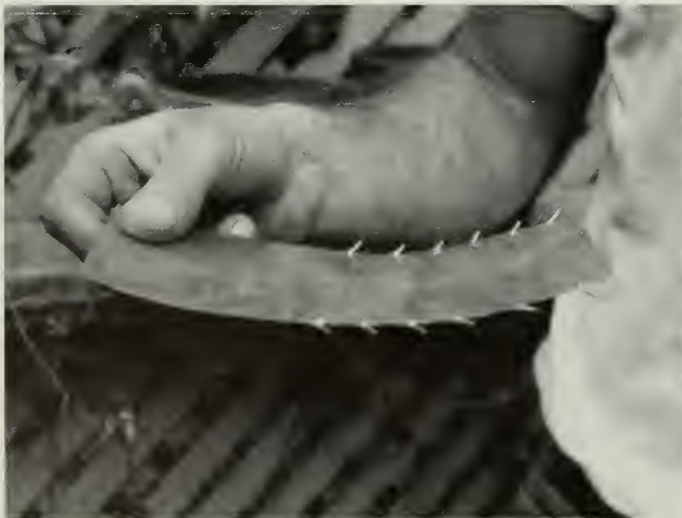
(e) The bib is cut along its edges and bent into a concave shape to create a friction fit.

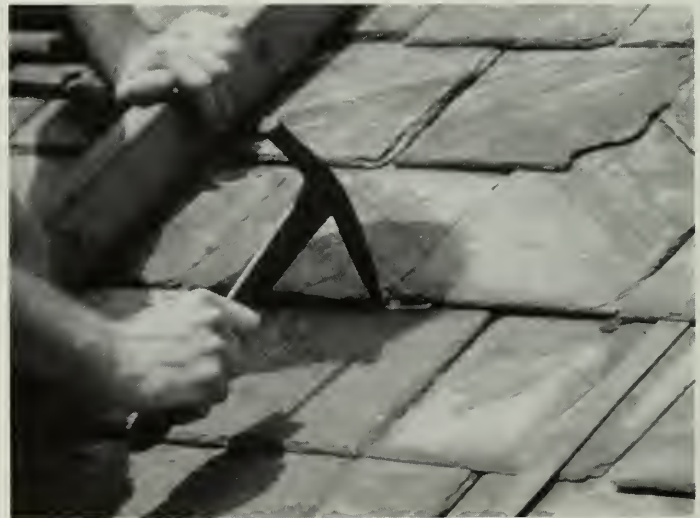
(f) The slate hammer is used to push the bib in place over the nail head.

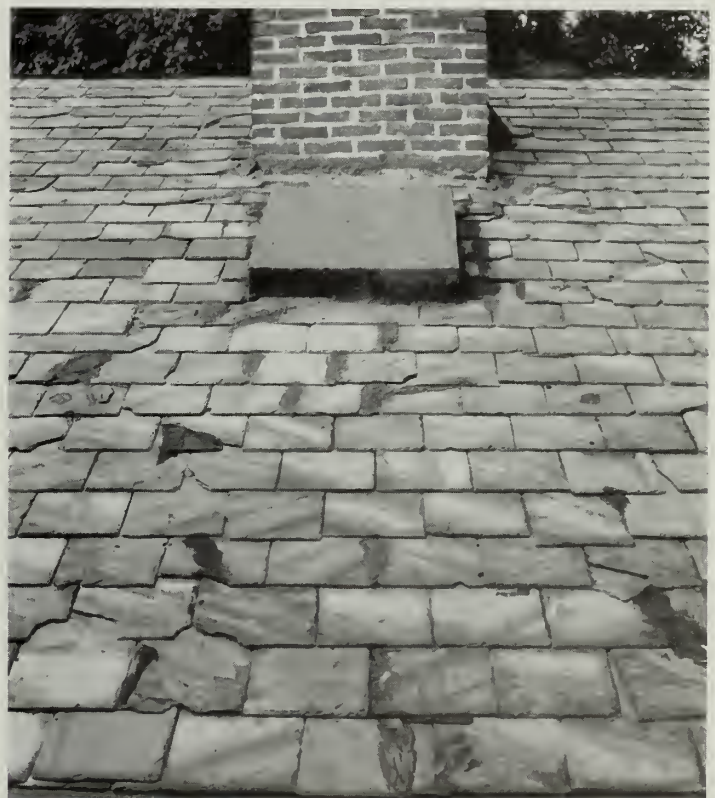
Figure 20. This roof has been poorly repaired numerous times in the past. The installation of mastic to seal out moisture has only exacerbated the problem. A timely repair and good maintenance could have extended the life of this roof.

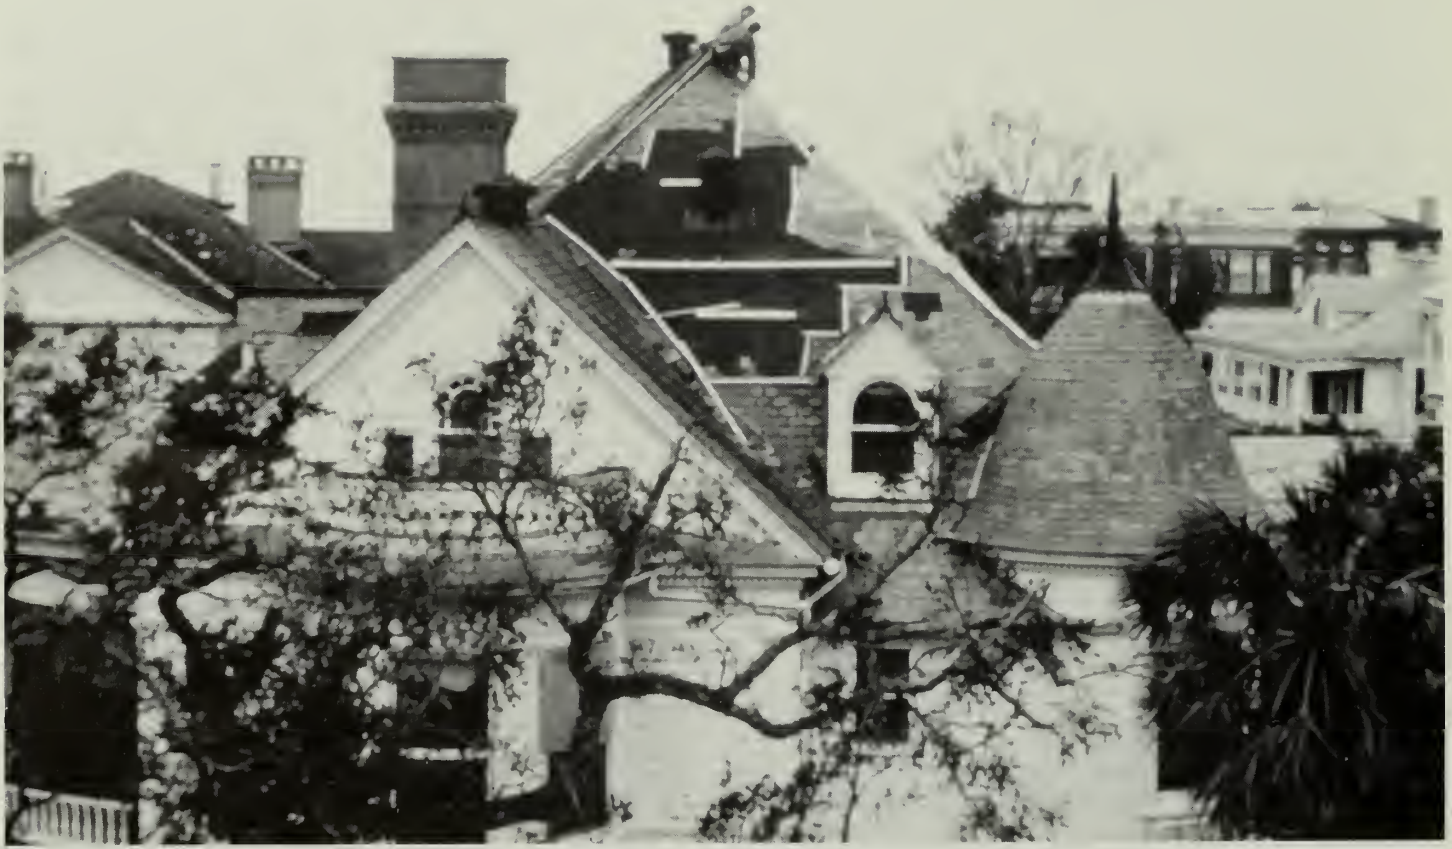
*Figure 21. As a result of hurricanes and other disasters, it may be necessary to temporarily stabilize a roof until materials can be obtained and a qualified roofing contractor hired. Heavy roofing felt was stitched into this slate roof to stop moisture penetration until matching slate was obtained for repair. Significant slate roofs should not be stripped off and replaced with asphalt shingles. Photograph courtesy of the National Park Service.*

In emergency situations, such as when severe hurricanes or tornadoes blow numerous slates off the roof, a temporary roof covering should be installed immediately after the storm to prevent further water damage to the interior of the building and to permit the drying out process to begin. Heavy gauge plastic and vinyl tarpaulins are often used for this purpose, though they are difficult to secure in place and can be blown off in high winds. Roll roofing, carefully stitched in to areas of the remaining roof, is a somewhat more functional solution that will allow sufficient time to document the existing roof conditions, plan repairs, and order materials (Figure 21).

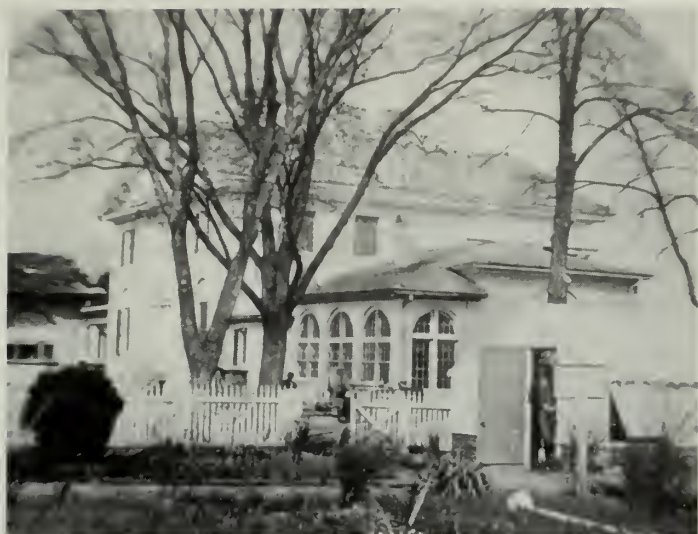
(a) Historic documentation was necessary to determine the historic configuration.

If repair is not possible and a new slate roof must be installed, it is important to remember that more than just the replacement of the slate is involved (Figure 22). The old slate should be removed to prevent overloading of the roof timbers. Stripping should be done in sections, with felt installed, to avoid exposing the entire sub-roof to the weather. In the process, rotted wood sheathing should be replaced and the roof timbers checked for signs of stress, including deflection, cracking, and twisting. If such conditions are found, a structural engineer experienced in working with older buildings should be consulted. Other repairs, such as chimney repointing, which may require access to the roof should be completed before the new roof is put on.

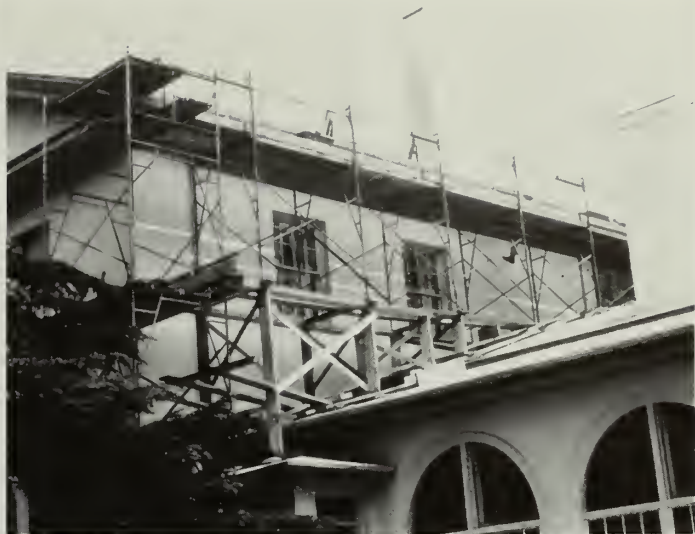
(b) Scaffolding was installed early to document existing conditions to determine extent of work.

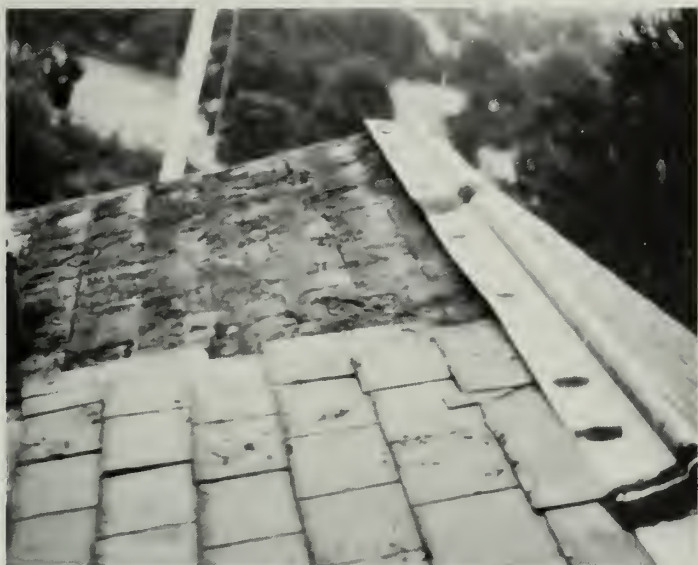
(c) Slate was removed in sections to avoid stress on timber framing.

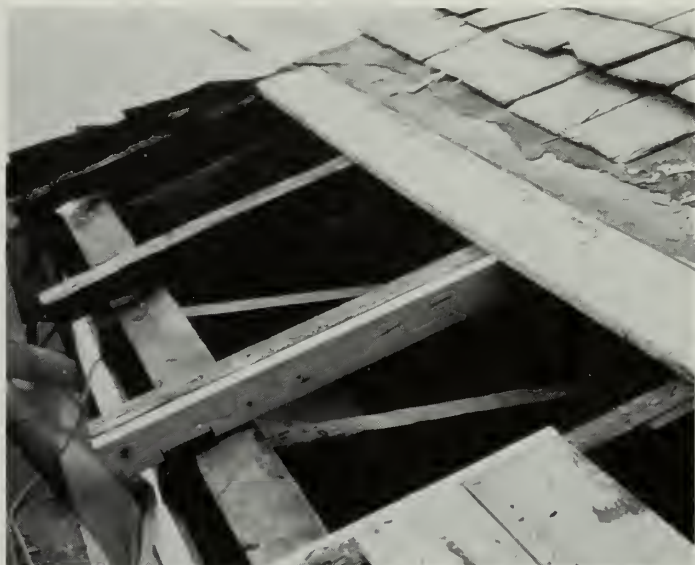
(d) Deteriorated sheathing was replaced and rafter tails were reinforced.

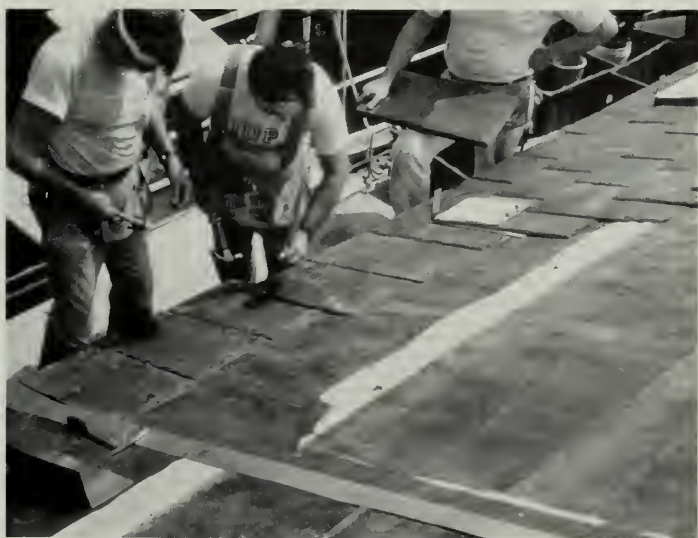
(e) Roofing felt was installed over decking; a rubberized membrane was used selectively at the eaves and under some flashing.

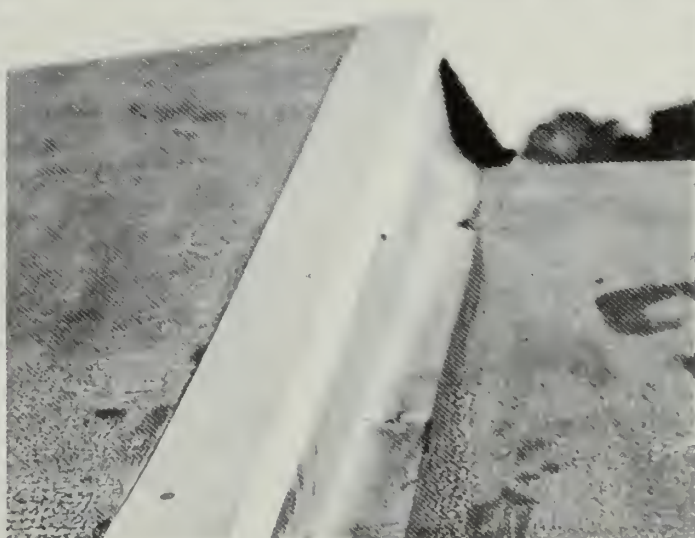
(f) Lead coated copper flashing was installed throughout. Seen is the offset between the portico roof and the main roof in progress.

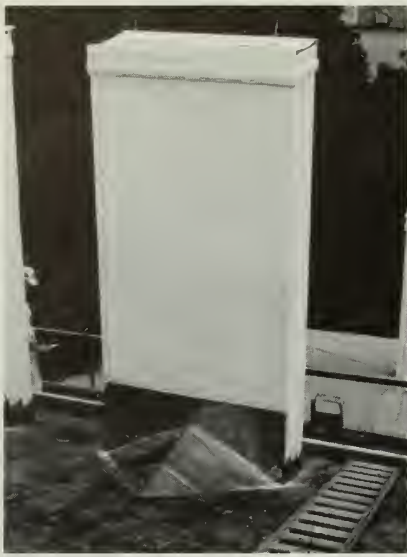
(g) Masonry chimneys were repaired and metal crickets were fabricated at the chimneys.

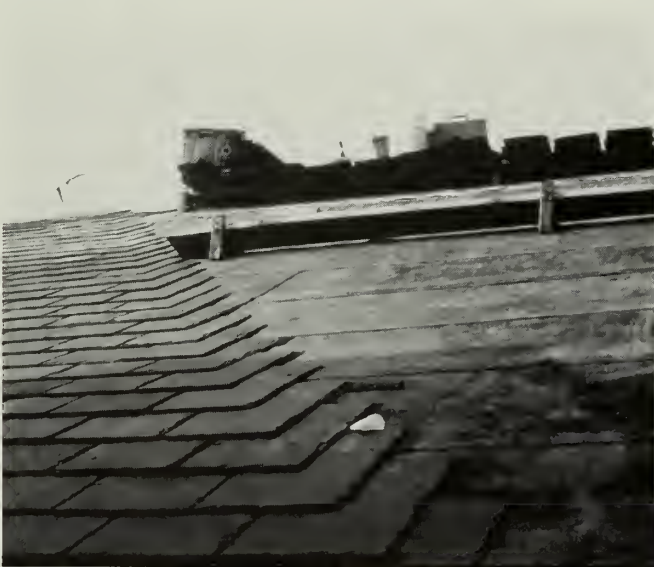
(h) This installation pattern allows the slates to be laid in courses leaving a temporary path of travel to avoid stepping on installed slates.

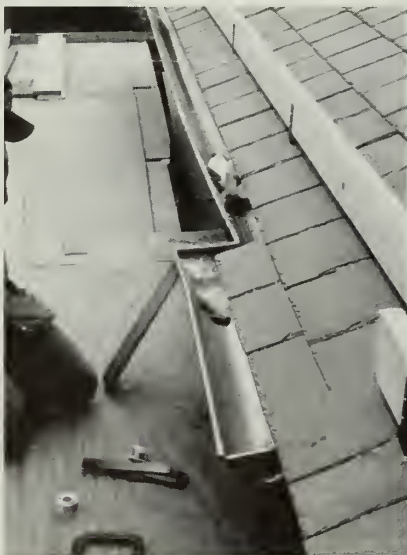
(i) Although the gutters and snow boards were the last elements installed, their support brackets were installed as the slates were laid.

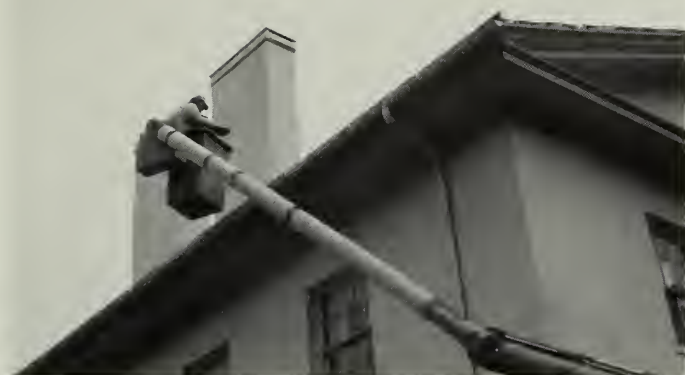
Figure 23. Slate roofs should not be walked on if at all possible. For large projects, lifts can be used to inspect roofs periodically to assess maintenance needs. Photograph courtesy of the National Park Service.
